FINAL COMPLETION REPORT For

COLD FOAM IN PLACE RECLAMATION Col-20 PM 10.2-28.2

North Region Materials Marysville, CA August 2006

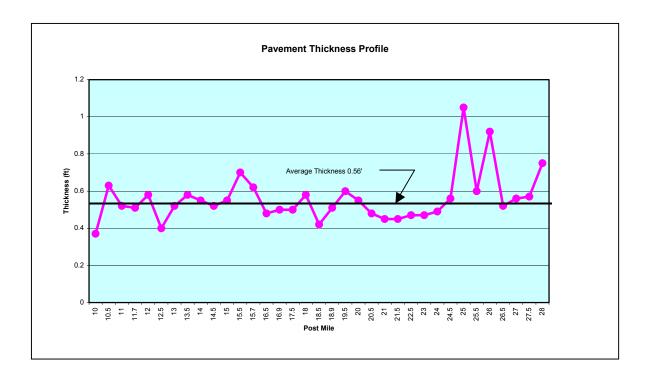
The average HMA thickness was 0.56', with a standard deviation of 0.13 with most cores showing a granular base below the HMA. Pavement profile is shown below:

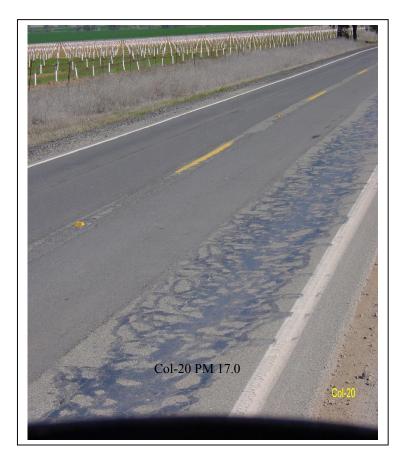
Post construction testing consisted of a detailed field review every 6 months and four deflection studies. Field investigations showed no visible distress for the years 2001-2005. Pavement was intact, with no signs of fatigue or thermal cracking. The maintenance crew reported one lateral crack developing at PM 11.2 in 2005 in the west bound lane. Upon investigation the crack was the result of embankment slippage and loss of lateral support. In July of 2005 another distressed area was identified at PM 17.5 in the eastbound direction. This distressed area coincided with an area that had no base under the HMA and as can be seen in the deflection graph below had the highest deflection of the project. The maintenance crew for the area indicated that the area around PM 17.5 was prone to yearly failures in both directions and wheel paths. At the time of preliminary testing and design, it was assumed that this segment would only last a maximum of two to three years, before remedial work would have to be accomplished.

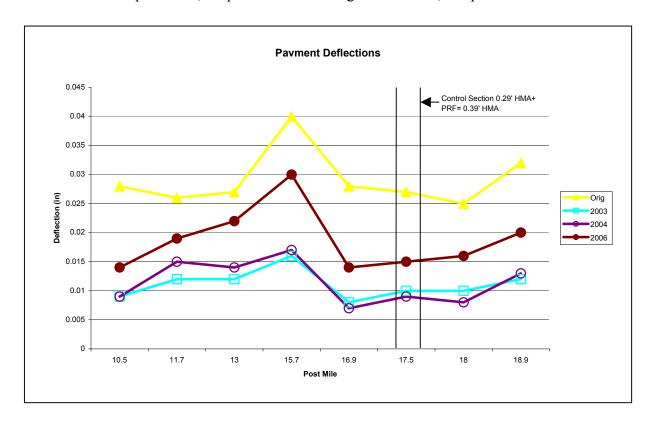
Deflection studies were conducted in 2000, prior to project starting, then again in 2003, 2004 and 2006. Deflection readings were taken in approximately the same location (+/-200 feet) and lane for all of the studies. As can be seen by the chart below, the highest deflections within the reclamation area occurred at post mile 17.5. This coincides with DCP readings for the area. Statistically, there were little to no changes between 2003 and 2004. Between 2004 and 2006, the average change in deflection was 0.007 inches with a standard deviation of 0.0027. This deflection increase coincides with a record number of

rain days for the 2005 rain season. California saw many road failures from the 2005 winter rains. This pavement, despite the rain and high water table, has performed well.

Under current rehabilitation guidelines based on 0.15 feet of HMA, and a Traffic Index of 9.0, the allowable deflection is 0.24 inches. Using the data from 2006 the average deflection was 0.018, with the 80th percentile being 0.020 inches, which is well under the allowable deflection.
